MISCELLANEOUS PAPER GL-92-32

## REANALYSIS OF MULTIPLE-WHEEL LANDING GEAR TRAFFIC TESTS

September 1992

Final Report

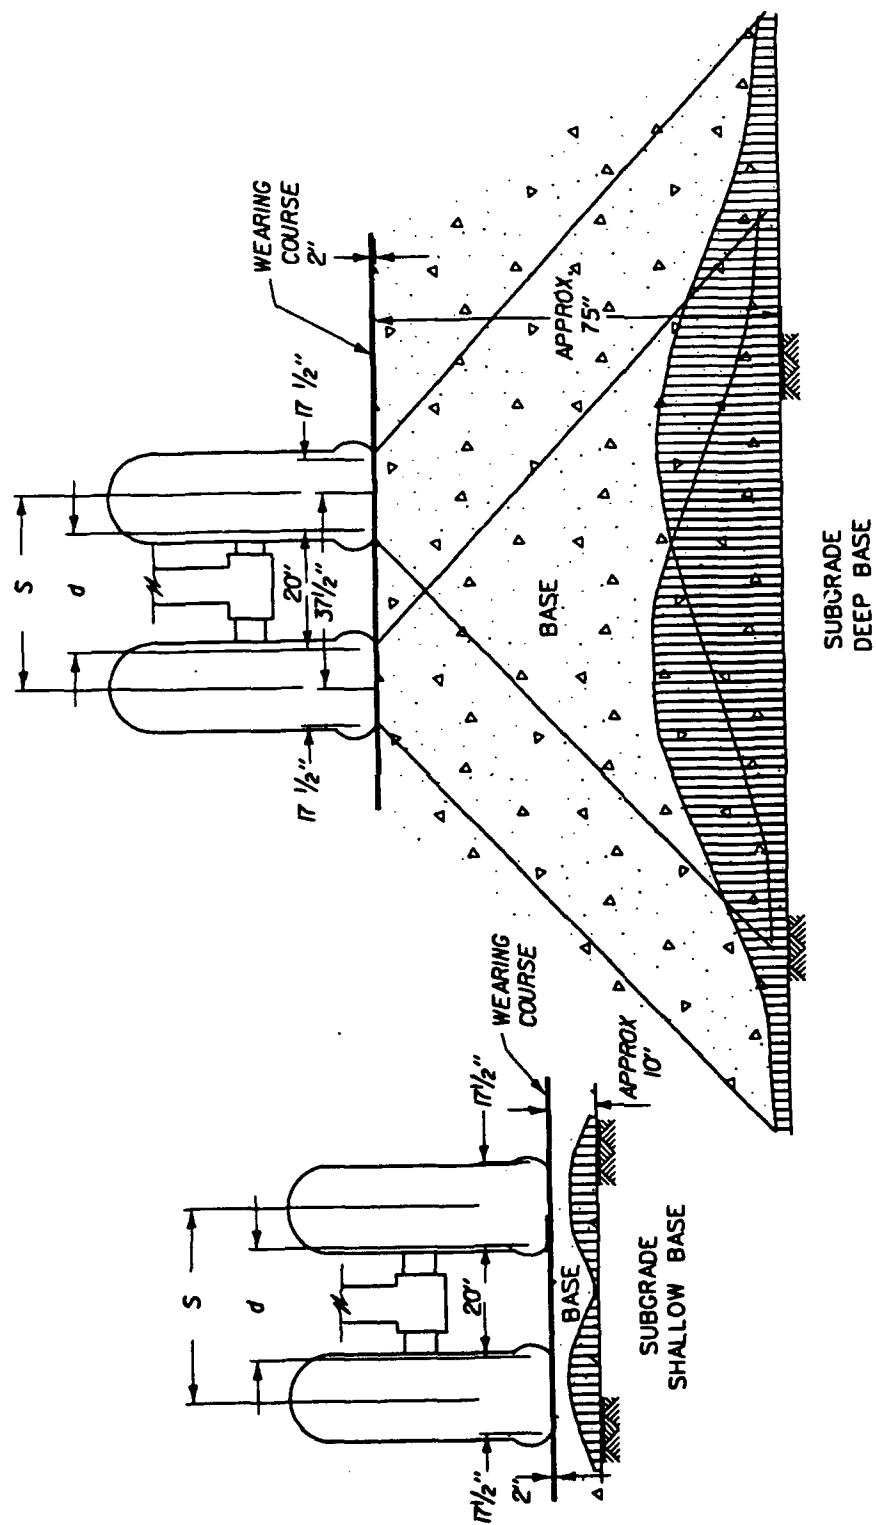
SCHEMATIC DIAGRAM OF  
B-29 DUAL WHEEL ASSEMBLY

Figure 1. Load distribution under dual wheels

1. As the B-17 and B-24 bomber aircraft of WW-II were supplanted by the much heavier B-29 and B-36 bombers, it became necessary to support the larger aircraft on more than single-wheel main landing gear. The B-29 accordingly was supported on main gear struts having dual wheels. Later the term twin became preferred. The B-36 had four wheels per strut called dual-tandem which is later referred to as twin-tandem.

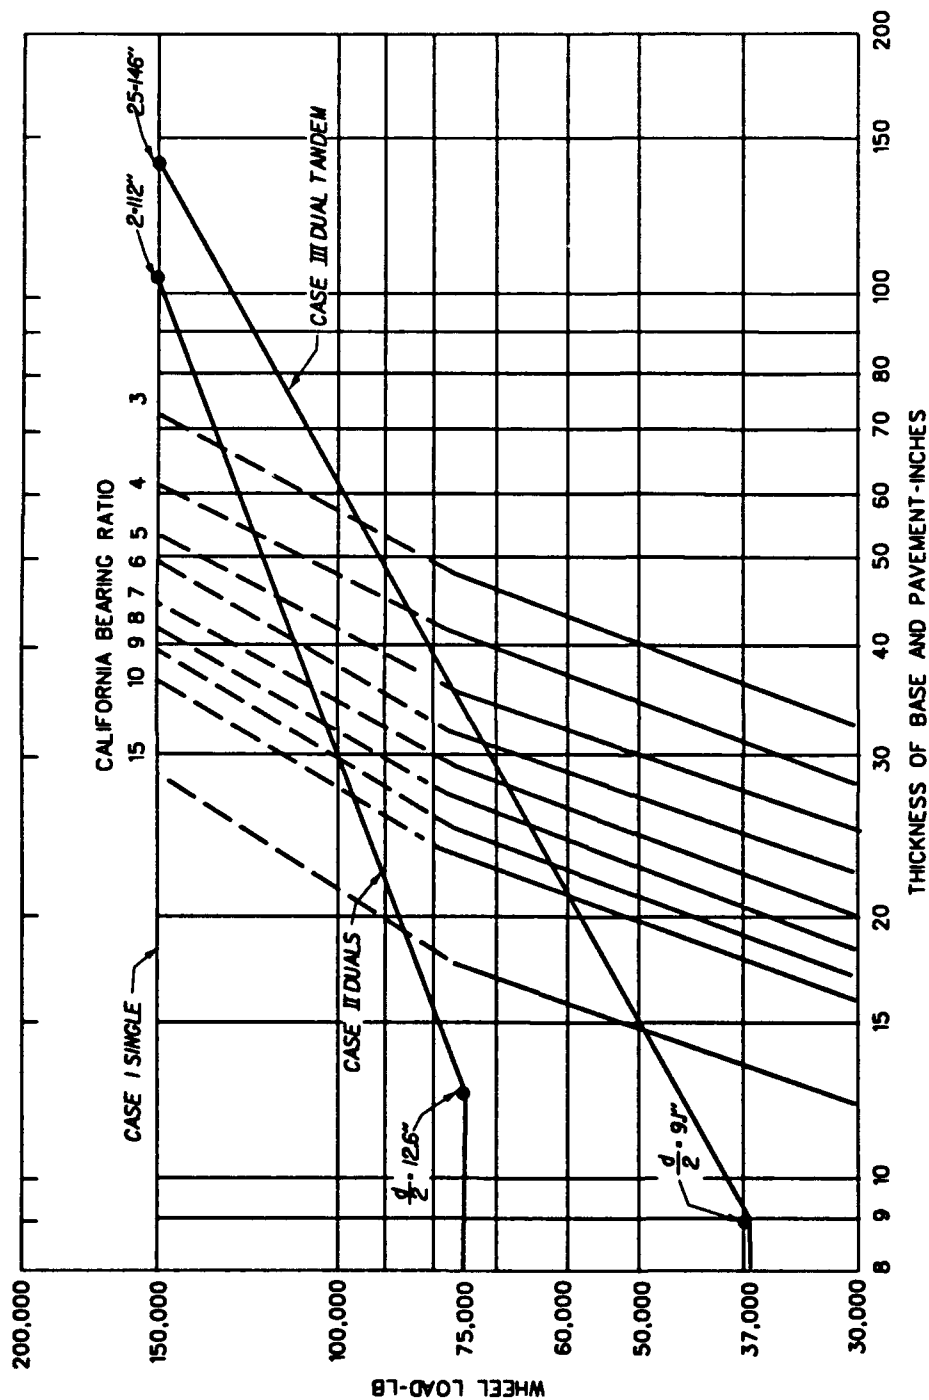
TENTATIVE METHOD OF COMPARING  
THICKNESS REQUIREMENTS FOR  
VARIOUS WHEEL LOAD ASSEMBLIES

Figure 2. Illustration of  $d/2 - S$  method

3. A method for establishing the ESWL for any dual or dual-tandem gear configuration was devised using available data and knowledge and reasonable geometric patterns. This method is recognized as the  $d/2$  and  $2S$  method. Figure 1 shows the definition of  $d$  and  $s$ . For this, the ESWL is the single-wheel load at depths less than  $d/2$ , where  $d$  is the distance between the edges of the two closest tire prints of a gear. ESWL is the total gear load on one of its wheels at depths greater than  $2S$ , where  $S$  is the center-to-center distance between dual wheels or the diagonal distance between centers for dual-tandem. Between these two depths, the ESWL was represented by a straight line on a plot of logarithm of load versus logarithm of depth as shown in Figure 2.

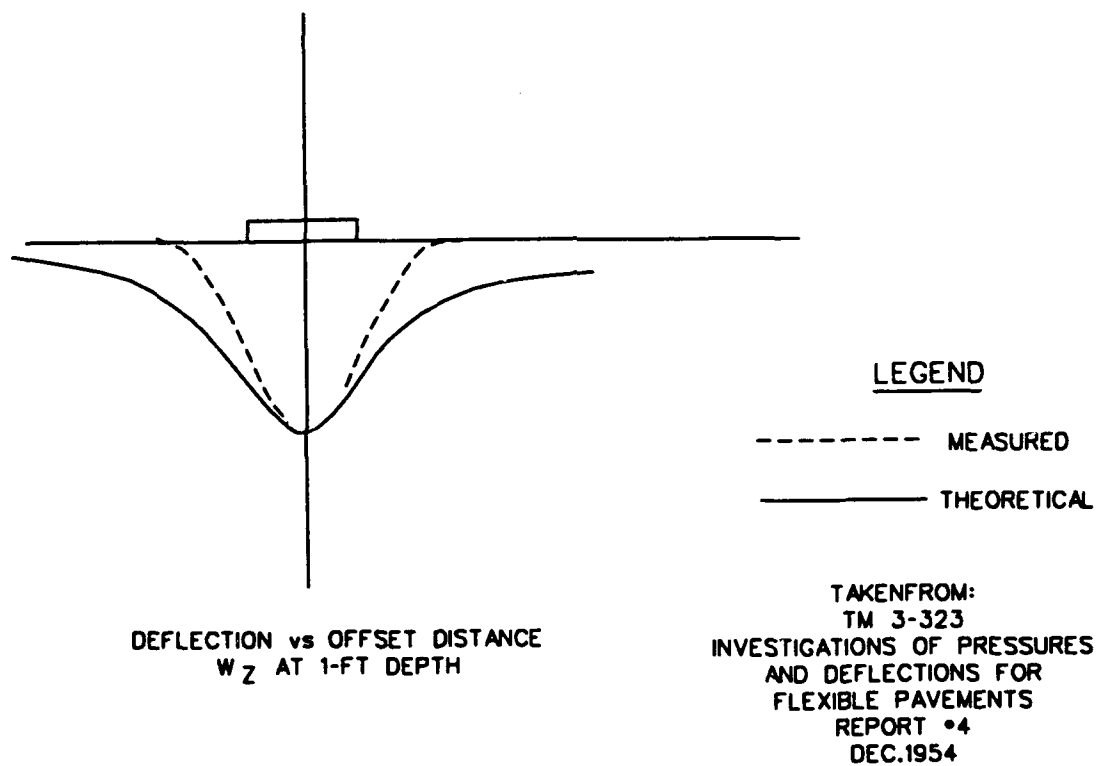
Figure 3. Illustration of discrepancy between theoretical and measured deflection

7. The reanalysis, which led to ESWL methodology based on theoretical deflections for a single layer model, recognized that the pattern for computed deflections, as compared to those measured in the stress-distribution studies, at wider offsets from the load center did not reduce to zero as did measured values. This implied that the contribution of wheels at wide offset spacing to the collective ESWL evaluation would likely be larger than actual and therefore conservative. Since relative magnitudes are small at wider offsets, this was not a serious concern for two and four wheel landing gear loads. It does, however, become significant, and likely seriously so, for many-wheel landing gear systems. This discrepancy is illustrated in Figure 3.

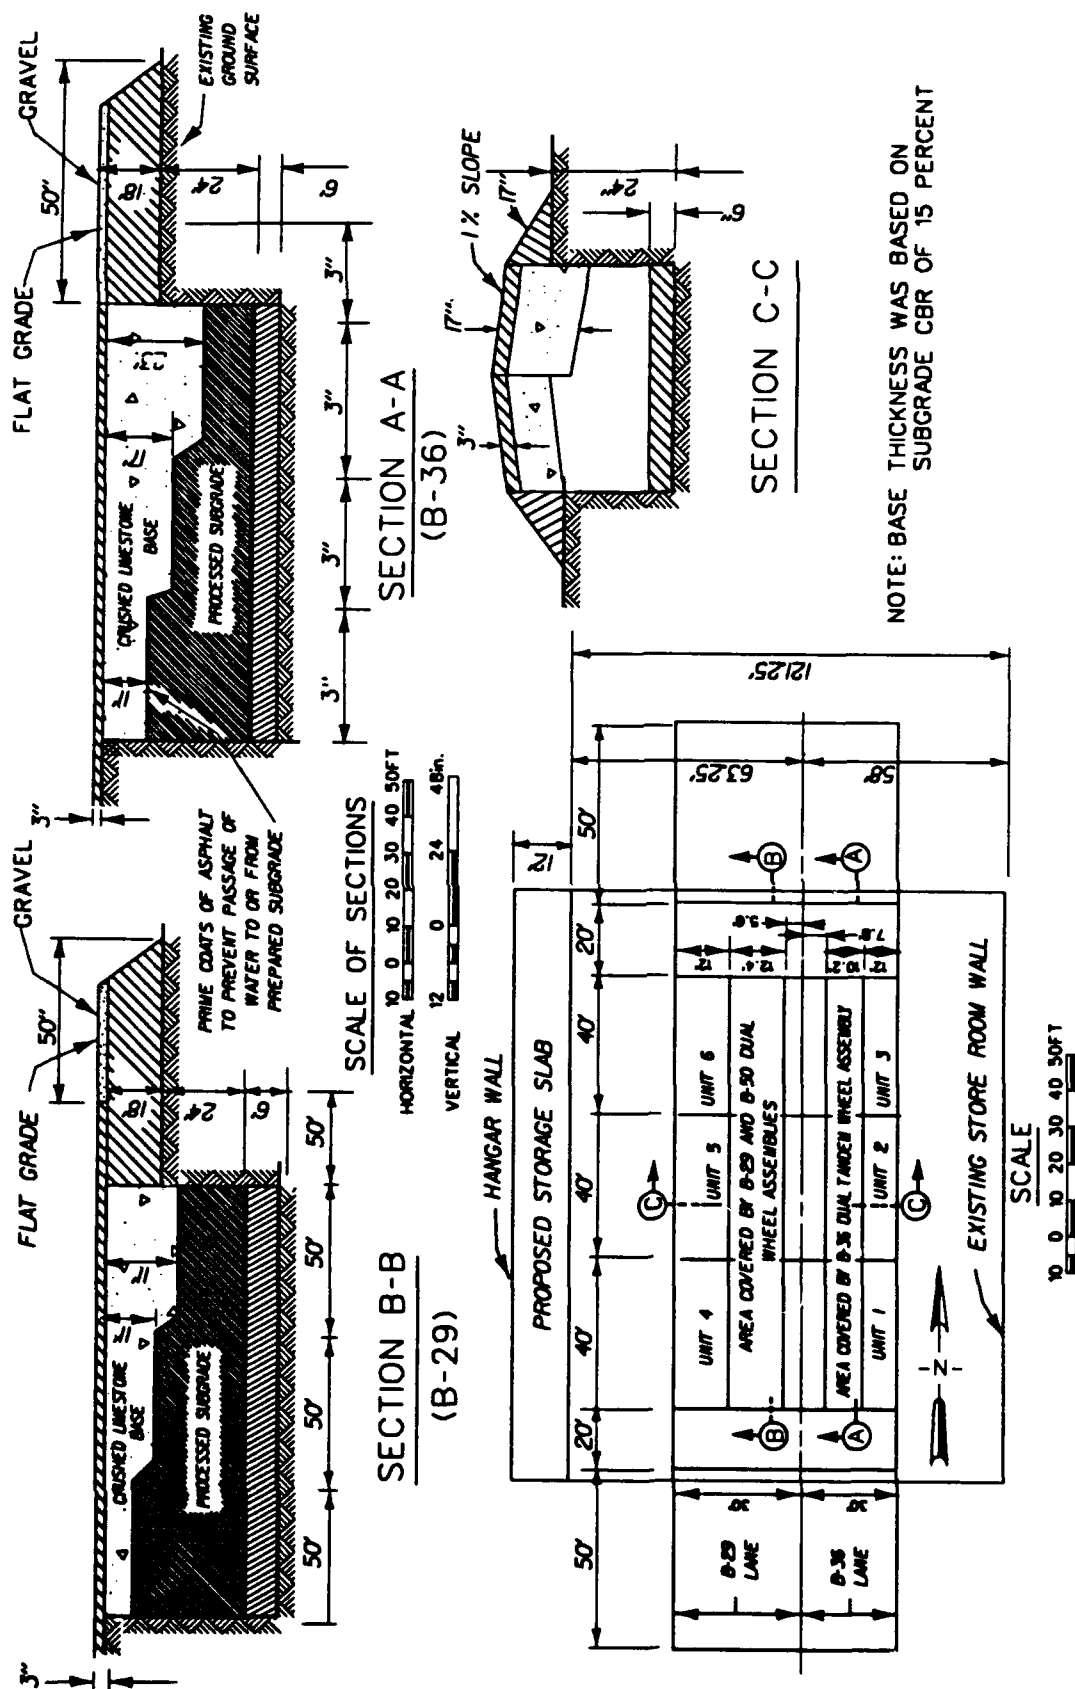
**Figure 4. Layout and cross sections of test lanes**

<u>Lane</u>	<u>Unit</u>	<u>Thickness of Structure</u>	<u>Surface</u>	+	<u>Base</u>
B-36	1	14 in.	3 in.		11 in.
	2	20 in.	3 in.		17 in.
	3	26 in.	3 in.		23 in.
B-29	4	10 in.	3 in.		7 in.
(B-50)	5	15 in.	3 in.		12 in.
	6	20 in.	3 in.		17 in.

Figure 4\* shows the layout and cross sections of the test lanes.

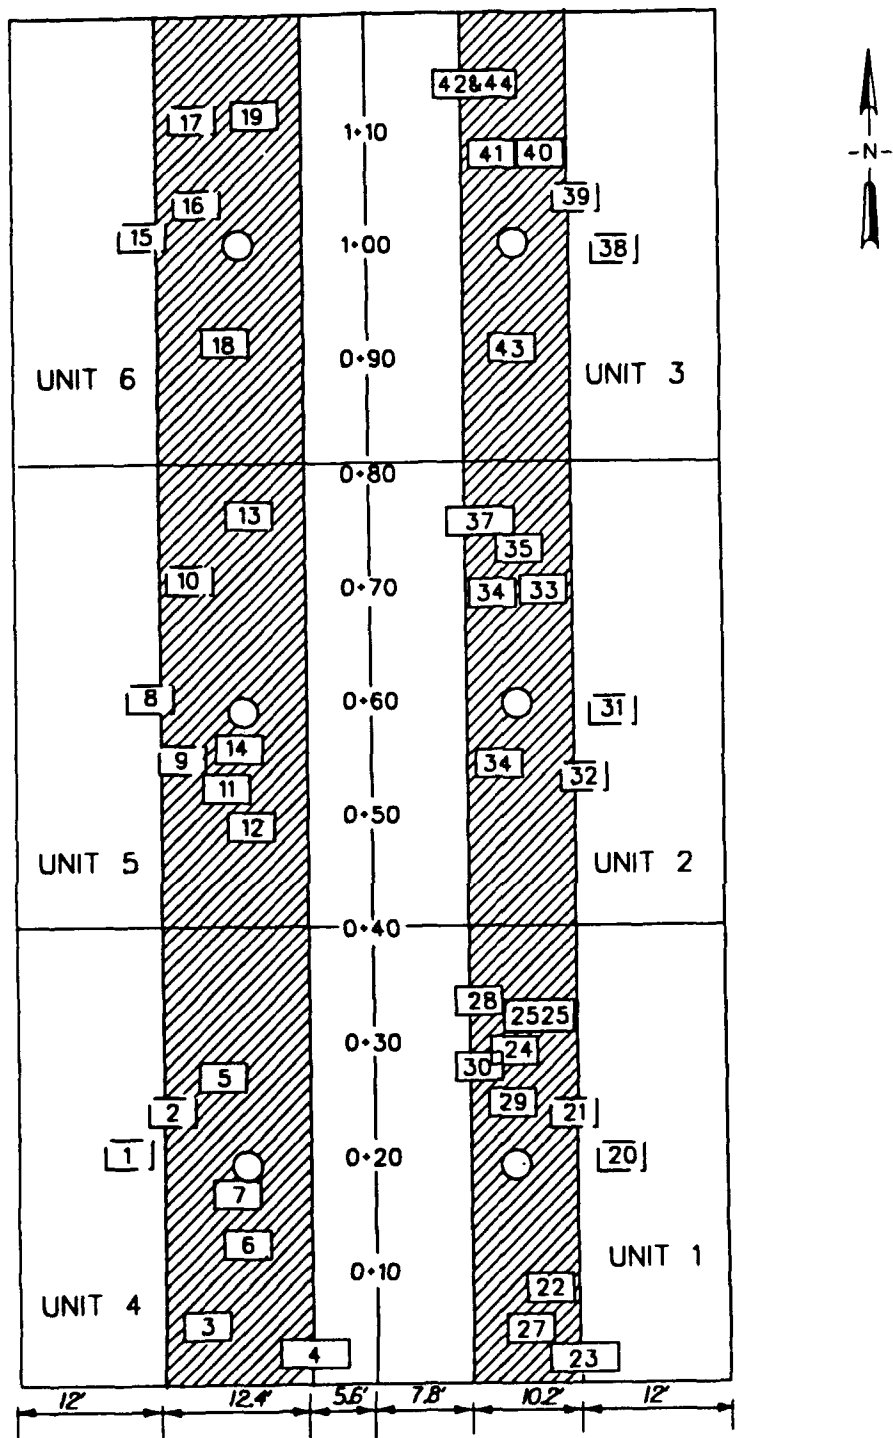
Figure 5. Location of test pits and deflection gages

Figure 5\* shows the locations of deflection measurements and of test pits in the six test units.

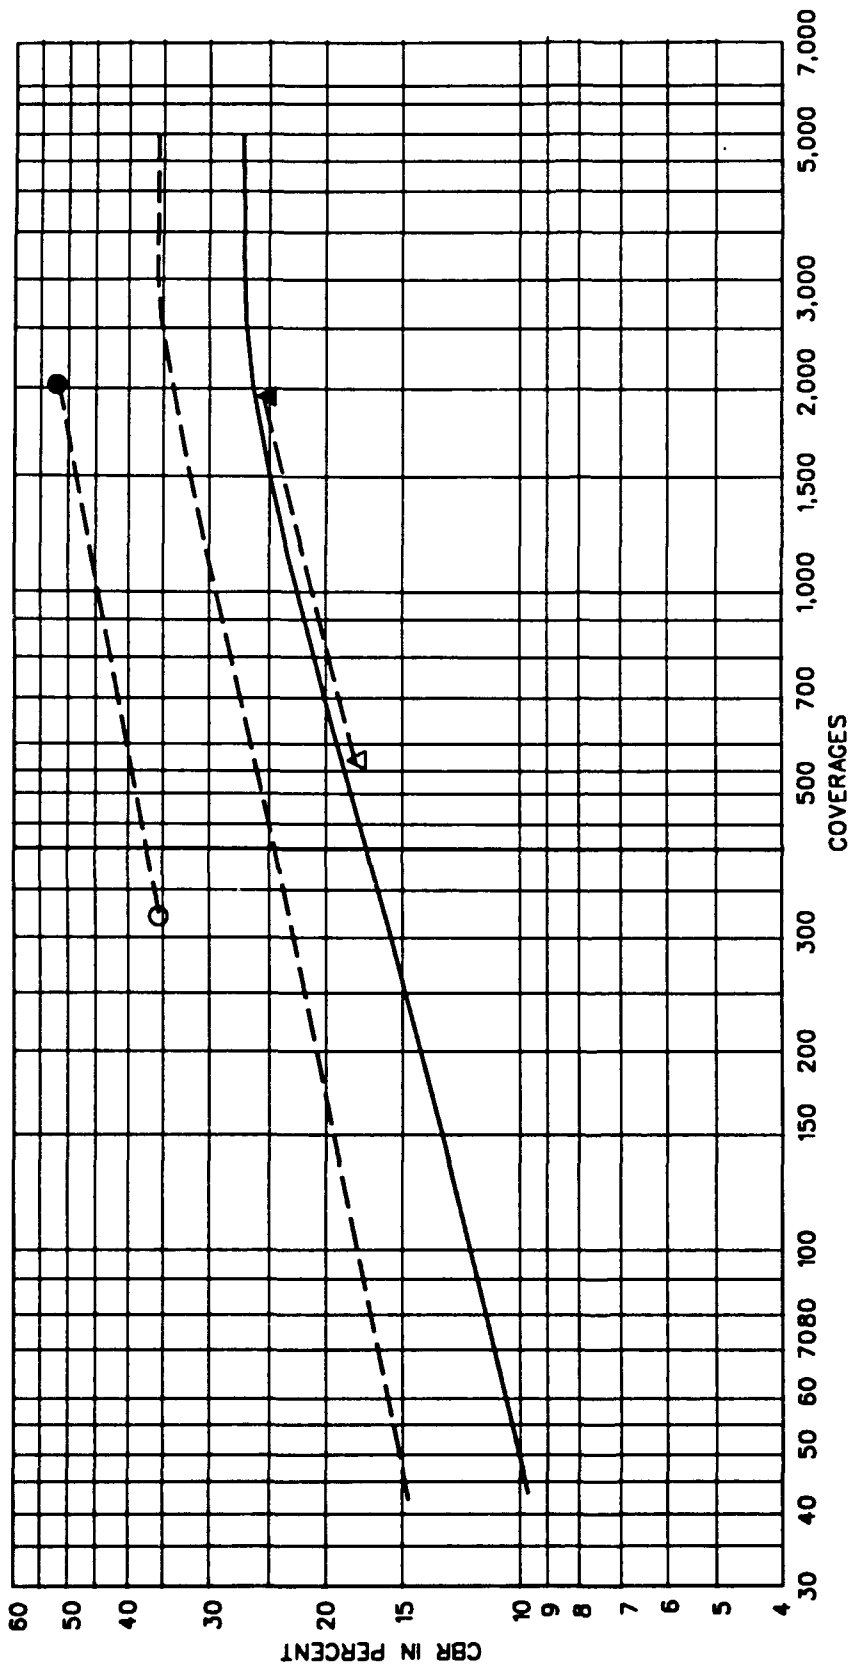
UNIT	ASSEMBLY LOAD	THICKNESS	CBR VS		LESS THAN 2,000 COVERAGES		ADJUSTED TO	
			COVERAGES	SYMBOL	COVERAGES	SYMBOL	2,000 COVERAGES	COVERAGES
4	100,000 LB (B-50)	10 IN.	---	O	328	●	50	
1	200,000 LB (B-36)	14 IN.	---	Δ	610	▲	25

The strength (CBR) data in this table are the primary concern of this reassessment. The evaluation determinations are for traffic of 2,000 coverages. The determinations are for actual applied traffic in all but the two cases indicated. One of these, Unit 1 under 200,000 lb B-36 traffic, failed after 610 coverages. The CBR was rated 18 and was adjusted to 25 in., an attempt to represent a subgrade strength which would have led to failure at 2,000 coverages. Figure 6\*\* shows the adjustment process. The second case of early failure, Unit 4 under 100,000 lb B-50 traffic, was considered failed at 328 coverages. The CBR was rated 35 and was adjusted to 50 to represent a 2,000 coverage inadequate behavior. Figure 6 also shows this adjustment.
